Title: Microscopic Examination of the Corroded Hagan Container Used to Store
Molten Salt Extraction Residue XBPS333

Microscopic Examination of the Corroded Hagan Container Used to Store Molten Salt Extraction Residue XBPS333

Joshua Narlesky, Kennard Wilson and Elizabeth Kelly

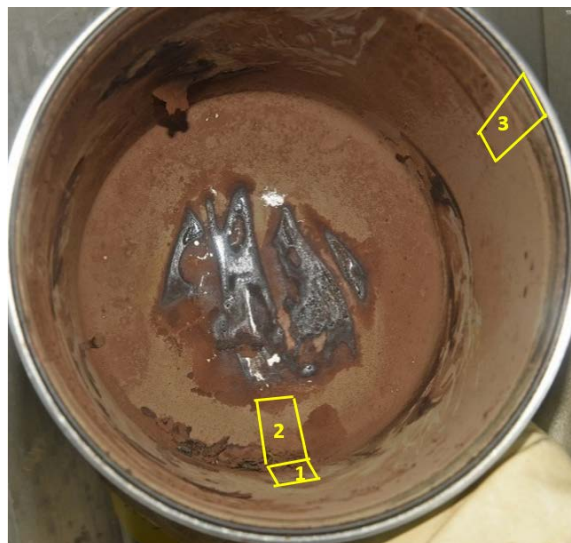
Figure 3. Approximate locations of the specimens obtained from the XBPS333 Hagan container.

Three representative specimens were obtained from the Hagan container by cutting with a low-speed trim saw. The approximate locations of the specimens are shown in Figure 3. Specimen 1 was obtained from the container sidewall near the bottom of the container. Specimen 2 was obtained from the container bottom. Specimen 3 was obtained from the container sidewall near the top of the container and included the collar. One specimen of an unused Hagan container was also obtained in the same location as Specimen 3. All three specimens were cleaned by placing each in a beaker of 2M nitric acid inside an ultrasonic cleaner for 30 minutes. After cleaning with nitric acid, the specimens were placed in a beaker of deionized (DI) water inside the ultrasonic cleaner for two minutes. The specimens were then air dried and imaged with a macroscopic camera. The remainder of the container and lid were cleaned by wiping with DI water on a wet cloth.

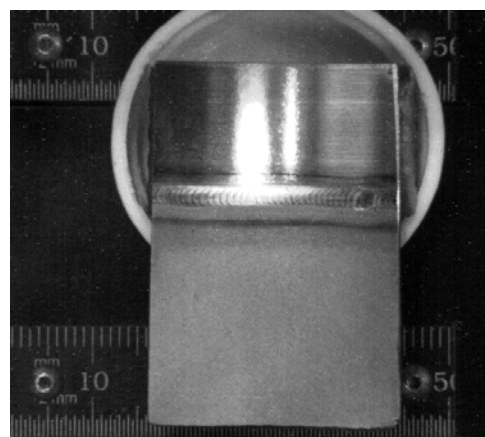
To control for the effects of the cleaning process, the specimen from the unused Hagan was cleaned with 2M nitric acid, rinsed in DI water, and air dried. An image showing the condition of the unused Hagan specimen after cleaning is presented in Figure 6. No changes were observed in the appearance of the surfaces at the macroscopic level. The coloration and finish of the sidewall outside of the weld region were consistent throughout the specimen.

Figure 4. Image showing the Inside surfaces of the unused Hagan container.

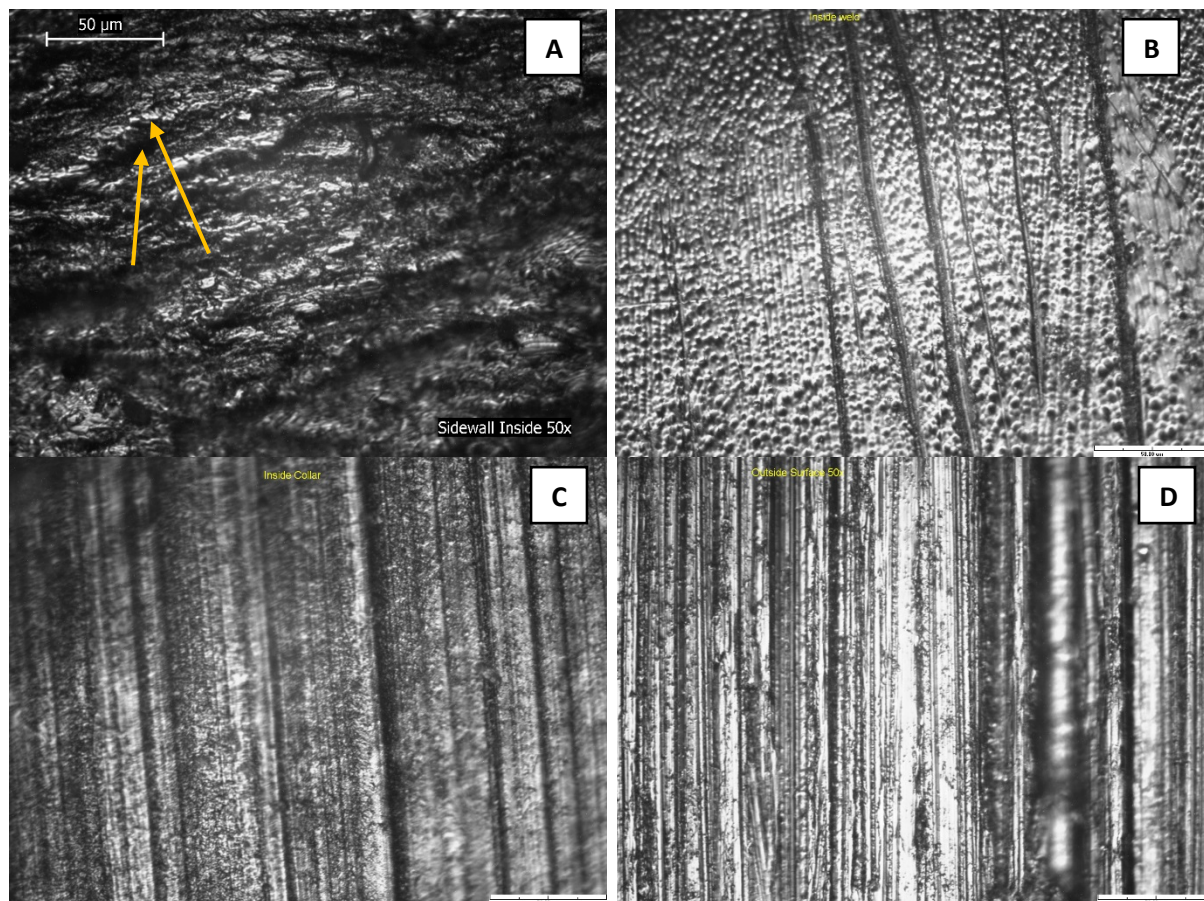
Representative microscopic images of the inside surfaces of the unused Hagan specimen were obtained in the sidewall, weld, and collar regions at 50X magnification. Additionally, one microscopic image was obtained for outside surface of the sidewall at the same magnification. The microscopic images are shown in Figure 9. The inside surface of the sidewall was characterized by an uneven surface showing a series of irregular features resembling ridges and valleys indicated by yellow arrows in Figure 9A. The weld region appeared to have a dimpled surface throughout with scratches running through the region. The collar was characterized by the circumferential machine marks (shown as vertical lines in Figure 9C). No pits or cracks were observed in any of the regions.

Figure 9. Microscopic images of the unused Hagan container imaged at 50X magnification before cleaning. (A) Inside sidewall below weld, (B) Inside sidewall at the middle of the weld, (C) Inside collar, (D) Outside sidewall. (The length of the scale bar at the bottom-right of each image represents 50 microns).

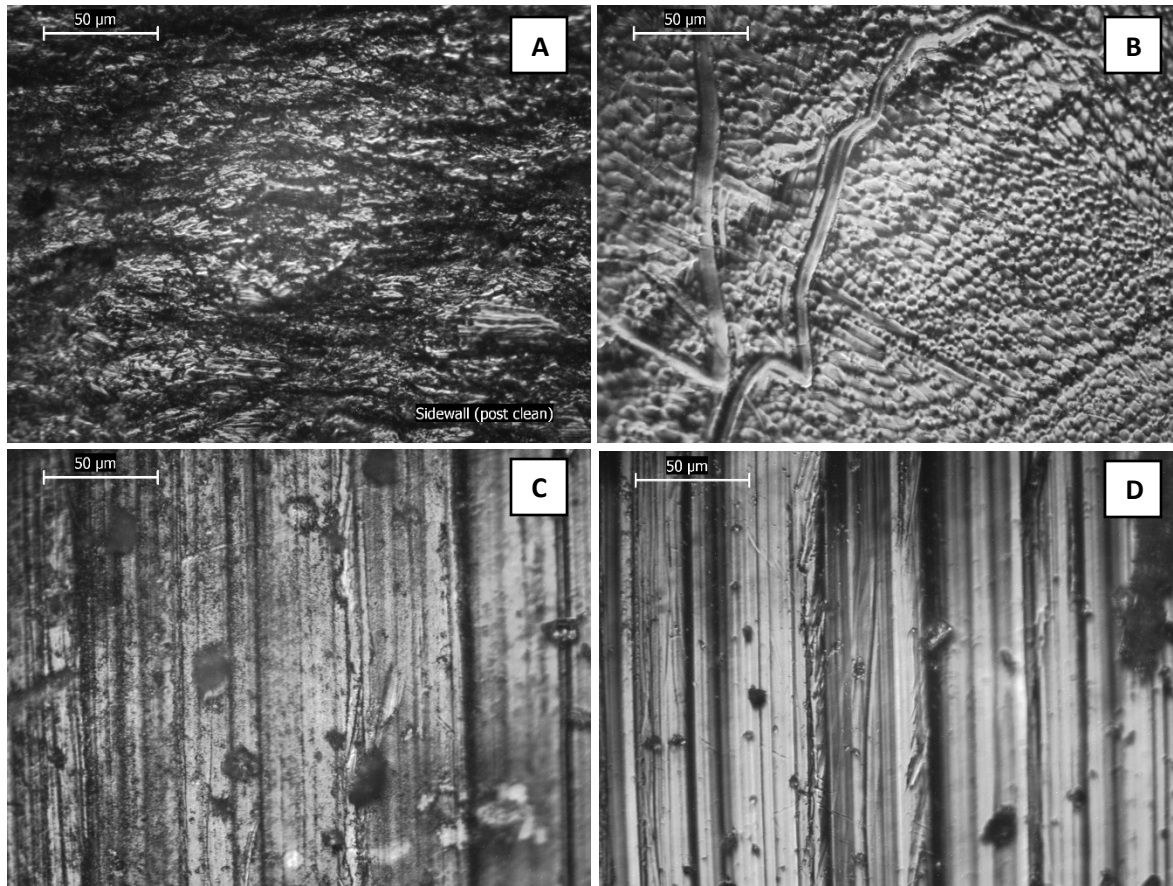
An additional set of microscopic images of the inside surfaces of the unused Hagan after cleaning were obtained in the same regions. These images are shown in Figure 10. The surfaces appear to be unaffected by the cleaning solutions, based on the similarity of the features in each region both before and after cleaning.

Figure 10. Microscopic images of the unused Hagan container imaged at 50X magnification after cleaning. (A) Inside sidewall below weld, (B) Inside sidewall at the middle of the weld, (C) Inside collar, (D) Outside sidewall. (The length of the scale bar at the bottom-right of each image represents 50 microns).
